North Coast Regional Water Quality Control Board

**Inspection Report for August 7, 2020 Consent Inspection,
Humboldt County Assessor's Parcel Number (APN) 214-142-012-000 (the
"Property")**

File: Cannabis Program Inspections, Humboldt County, August 7, 2020, California
Property Solutions Property, CIWQS Place ID 843377

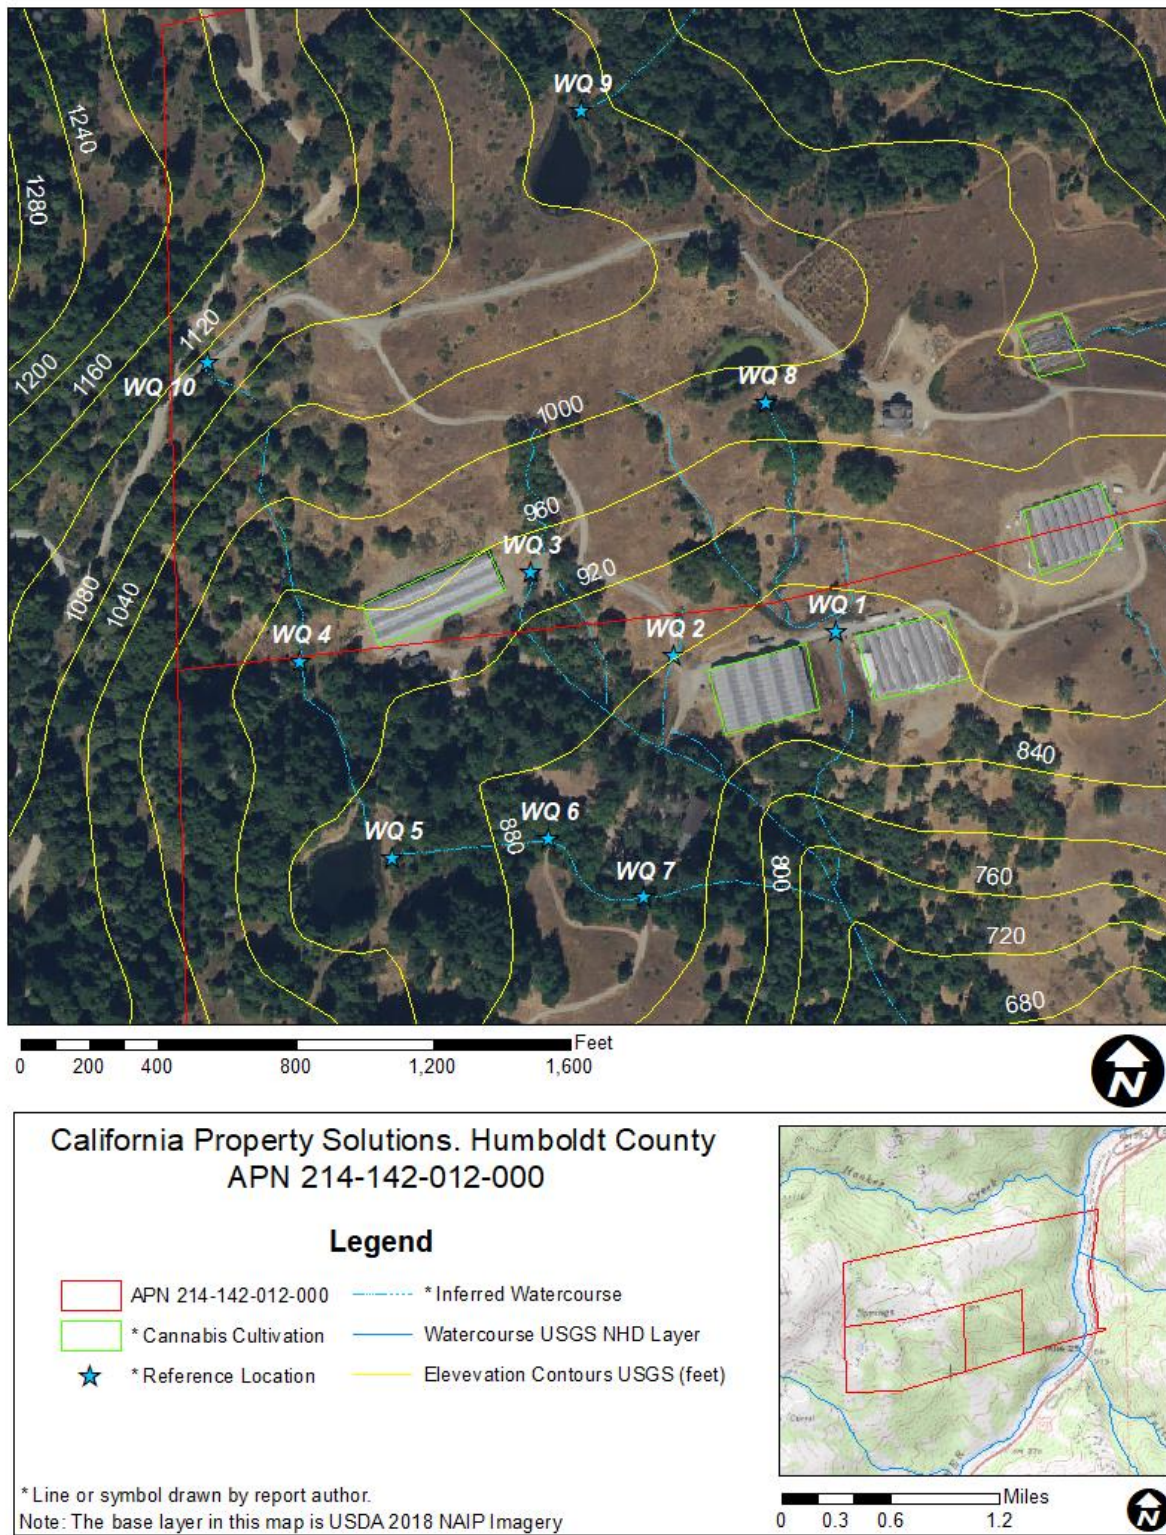
Figure 1: Annotated map of property.

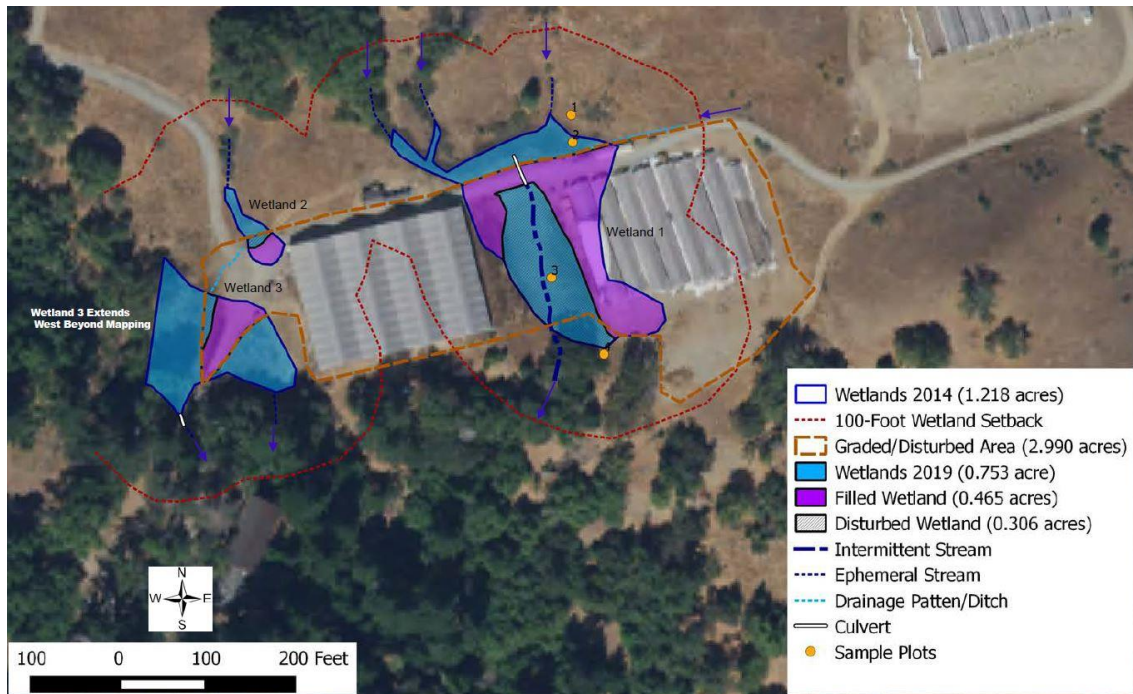
On November 15, 2019, TRC submitted to the Regional Water Board an Aquatic Resources Delineation (Wetland Report), prepared by Kyle S. Wear. The Wetland Report covers the three-acre area with suspected wetland that I had documented in my 2018 inspection report, and it identifies and delineates a filled wetland on the west and east sides of the western greenhouse and at the eastern greenhouse (Picture 1).

West of the westernmost greenhouse in the wetland study area at WQ 2, there is an area of bare earth where a north-south trending road intersects with the east-west trending road (Picture 1). Wetland features are still visible northeast of the road intersection and the SMP identifies a culvert carrying flow from the northeast to the western side of the intersection and two culverts returning the flow to the east side of the road further south (Picture 1). I recommended this area be included in the more detailed topographic survey area.

Picture 1—Aquatic Resources and Impacts Map from November 15, 2019, Wetland Report, prepared by Kyle S. Wear.

1. Engage an appropriately qualified licensed professional to develop a detailed topographic survey of the wetland feature(s) at WQ 1 and WQ 2 to assist in identifying the extent of the wetlands that were present before the site was impacted in 2015. The survey should identify locations of non-impacted areas at the boundary of the earthwork as a reference of what the pre-impact topography was. The pre-impact topography should be compared to the current topography to show how much material was moved, where it was moved from, and where it was moved to.

2. Retain an appropriately qualified, licensed engineer to develop/review the plans described under recommendations 3 and 5 below.
3. Develop a plan to restore the wetland features at WQ 1 and WQ 2 to their extent and quality prior to the impacts discussed above, and a proposal for compensatory mitigation for the temporal impacts to these features.

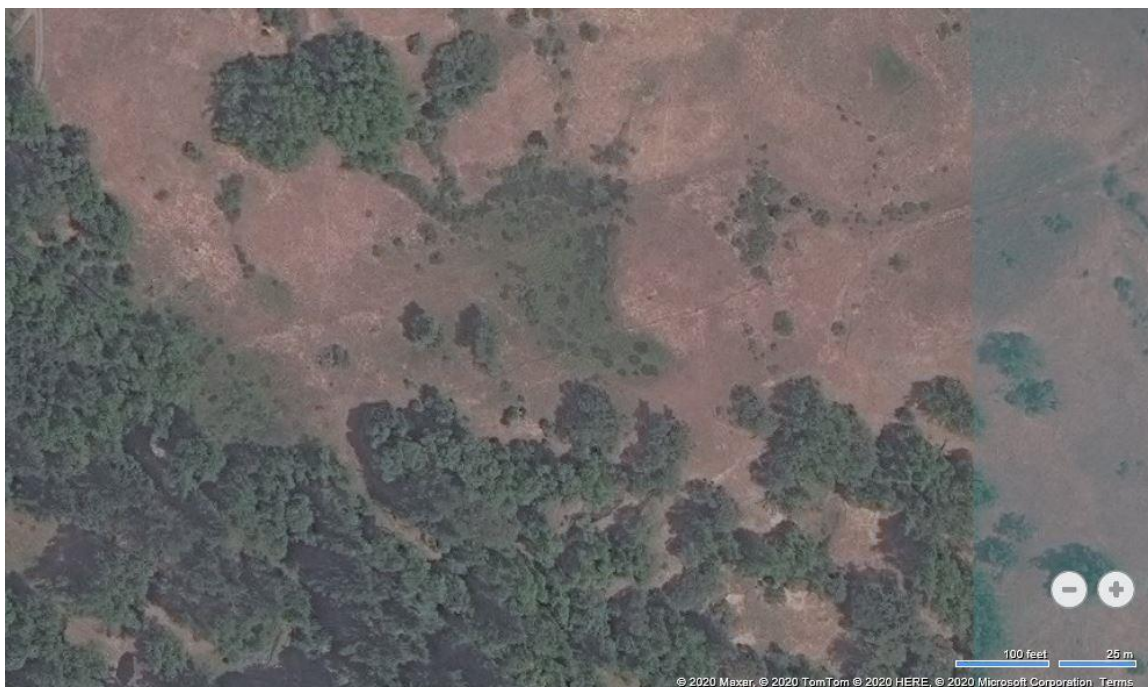
Although vehicles may have driven across the wetland area historically, aerial imagery suggests the compaction and placement of earthen fill that makes up the east-west trending road at WQ 1 and the north-south trending road at WQ 2 were constructed at the time of the greenhouse pad developments, between June 2015 and July 2016. The existing roads interfere with the hydrology of the wetlands; the single culvert at WQ 1 concentrates flow scouring a watercourse within the wetland and the flow at WQ 2 is routed through culverts away from areas that may have formerly hosted wetland habitat.

Picture 2—Aerial Image dated June 9, 2015, accessed with Digital Map Products' Land Vision service.

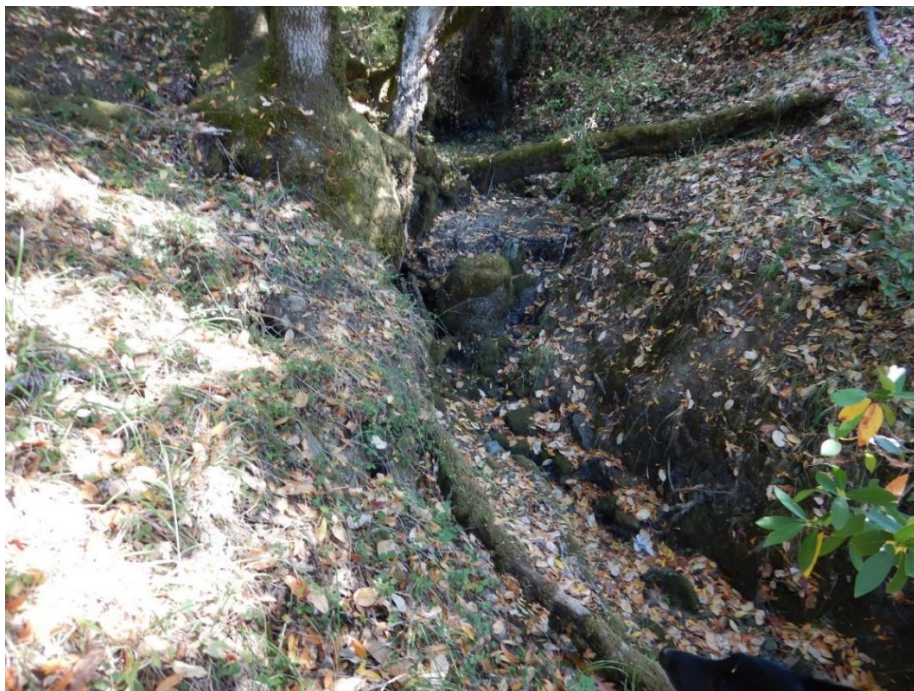
The Inspection Map, above, shows inspection points referenced and discussed below. Inspection participants met north of Redway at the east side of the bridge over the South Fork Eel River near Wood Ranch Road and agreed to inspect the Wetland Report study area at WQ 1 (Picture 1 and Picture 2) first. We entered the Property from the west, drove to WQ 1 and parked on the road crossing the feature from west to east. I observed that the wetland feature upslope and north of the road was intact. I observed that the road diverted all water from the wetland north to a single culvert in the middle of the study area, concentrating the flow. A watercourse, which is not visible in the pre-impact aerial imagery (Picture 2), had channelized from the culvert outlet to the southern extent of the cleared area where topography steepens, and the channel incises more deeply (Picture 3).

Picture 3—Looking upstream at a stream channel from the south of the wetland study area. The channel originates at the culvert at WQ1.

The SMP proposes armoring the culvert outlet at WQ 1 this fall. Treating this location at this stage would be temporary pending a full wetland restoration plan. The temporary work of armoring the culvert outlet would require a WQC.

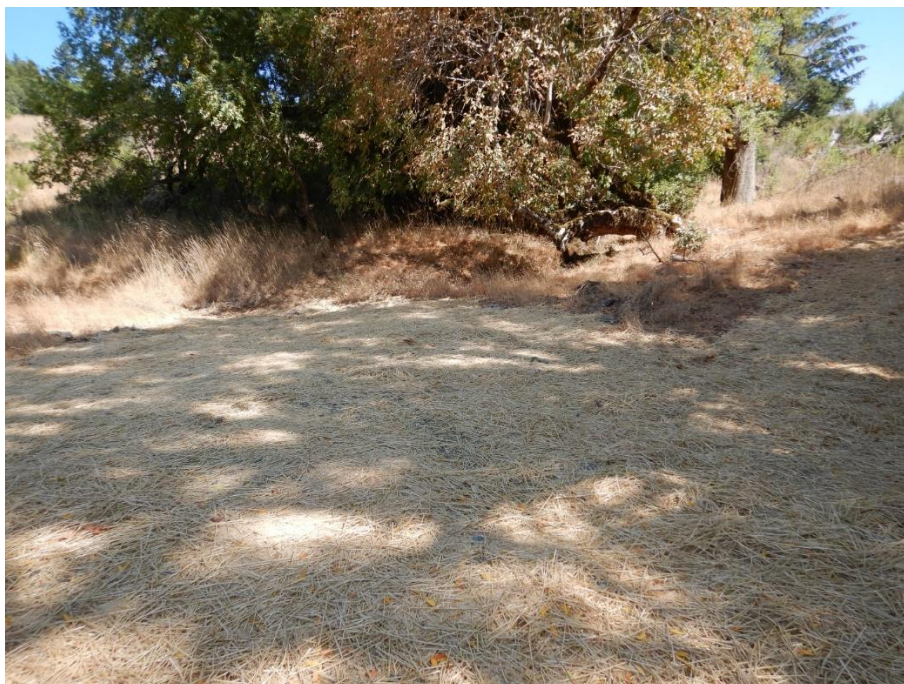
We walked west to WQ 3 where more than 100 feet of watercourse had been culverted. I walked from the culvert inlet to the culvert outlet and observed another watercourse parallel to the current culvert outlet channel that was closer to the culvert inlet and appeared to have been the likely continuation of the culverted watercourse before the culvert was installed. I also observed that the edges of the pad occupying the culverted watercourse had been covered with straw and demarcated to prevent traffic (Picture 4). I observed that the watercourse that the culvert is currently discharging into is deeply incised, and also receives several flexible plastic pipes that collect and transport the stormwater runoff from the roof of the nearby greenhouse. The inspection team discussed redirecting the culverted watercourse to the more proximal channel and minimizing the length of channel that is culverted for the intended use of the area as an access road to reach the greenhouse immediately to the west.

Aerial imagery suggests that the watercourse was culverted at this location to access the greenhouse constructed for cannabis cultivation to the west. Culverting the watercourse at this location occurred without authorization. The entire length of culverted channel in addition to the part that is armored with rock is considered a permanent impact.

Picture 4—Looking north from road leading to greenhouse at WQ 3.

4. Develop a plan to restore the watercourse at WQ 3 that avoids all permanent impacts that are practicable, minimizes the impacts that are not avoidable and mitigates for any remaining impacts.

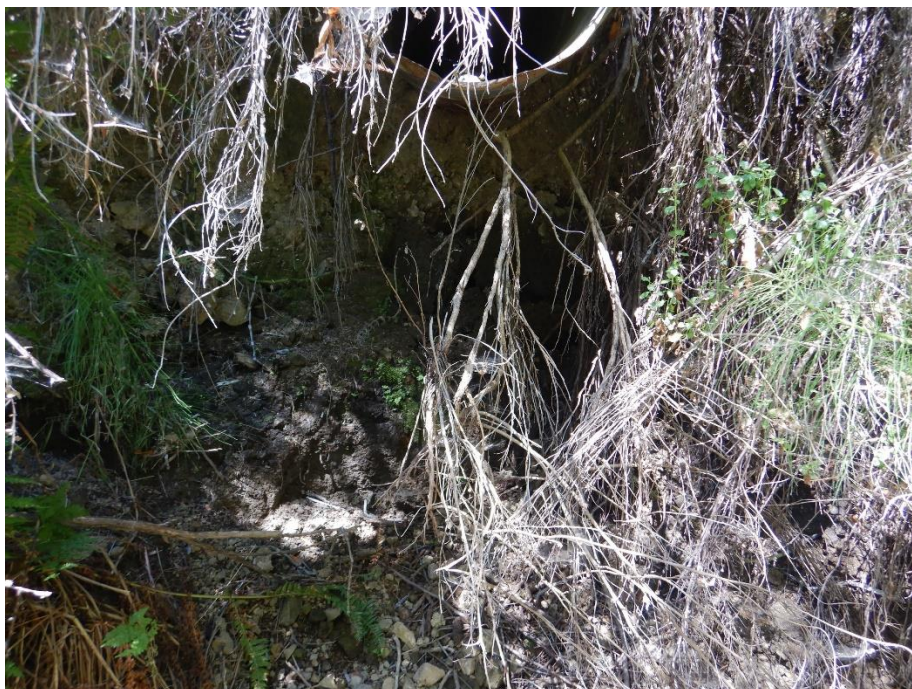
We continued walking south to a larger reservoir at WQ 5. I walked to the downstream side of the impounding berm and observed water seeping from the ground over a broad area north of the reservoir outlet. I observed that the reservoir outlet was a rusted corrugated metal pipe with no water flowing through it. I observed a void, several feet high and deep, that had eroded into the berm structure below the outlet (Picture 5). TRC personnel proposed lowering the berm at the outlet location. Ms. White suggested the dischargers consider a plan that removed a longer portion of the berm than just immediately above the outlet.

Picture 5—Looking at reservoir outlet located at WQ 5. Note the the edge of the outflow pipe is visible at the top of the image.

5. Develop a plan to decommission the impoundments at WQ 4 and WQ 5. Ensure any remaining portions of the berms are stable and do not threaten to discharge earthen material to receiving waters.

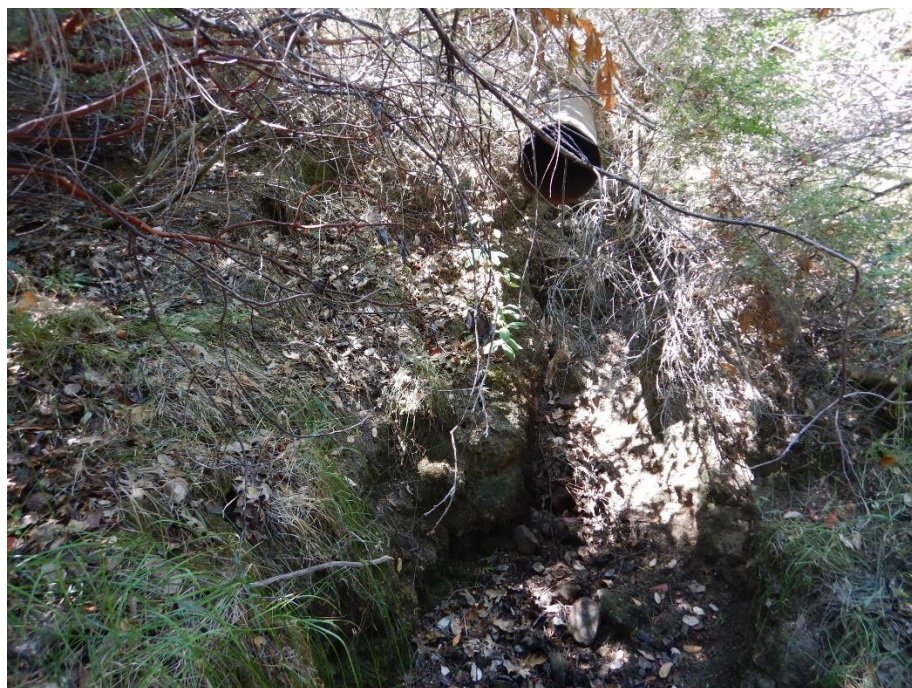
We returned to our vehicles at WQ 1 and drove east, then northwest, to a reservoir located at WQ 8. I observed some scour below the culvert outlet, but I did not observe any sloughing, cracks or evidence of water seeping through the reservoir berm. We then drove northwest to the reservoir at WQ 9. The impounding berm was heavily vegetated. I observed the corrugated metal pipe reservoir outlet extending several feet from the reservoir berm (Picture 6) and discharging into a scour pool downstream from the berm (Picture 7). I observed pooled water in the watercourse receiving the pond outflow.

Picture 6—Looking upstream at reservoir outlet located at WQ 9.

6. Proceed with the scope of work proposed in the SMP for the culverts at WQ 6 and WQ 7.
7. Add to the SMP annual monitoring for the reservoirs at WQ 8 and WQ 9 that includes inspection for discernible cracks in any portion of the berm, freeboard height above the outlet structure, and any signs of underflow at the outflow exit or localized scour immediately downstream from the outlet.

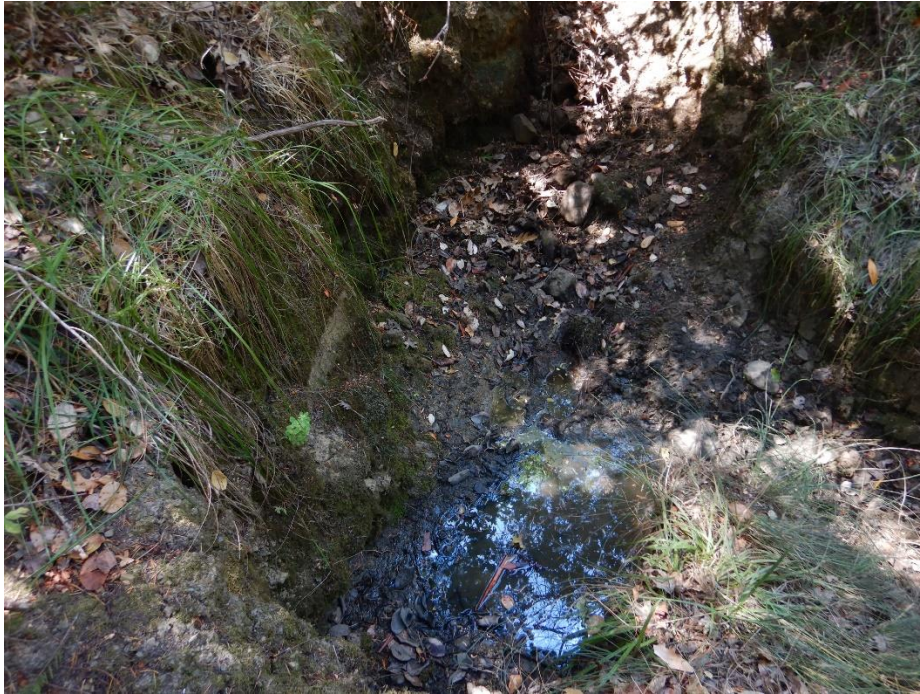
Picture 7—Looking downstream from reservoir outlet located at WQ 9.
